DELAWARE RIVER BASIN  
QUEEN ANNE CREEK, BUCKS COUNTY  
PENNSYLVANIA  
NDS ID PA. 00801  
DER ID 9-171

# OXFORD VALLEY MALL DAM

PHASE I INSPECTION REPORT  
NATIONAL DAM INSPECTION PROGRAM

11 JANUARY 1980

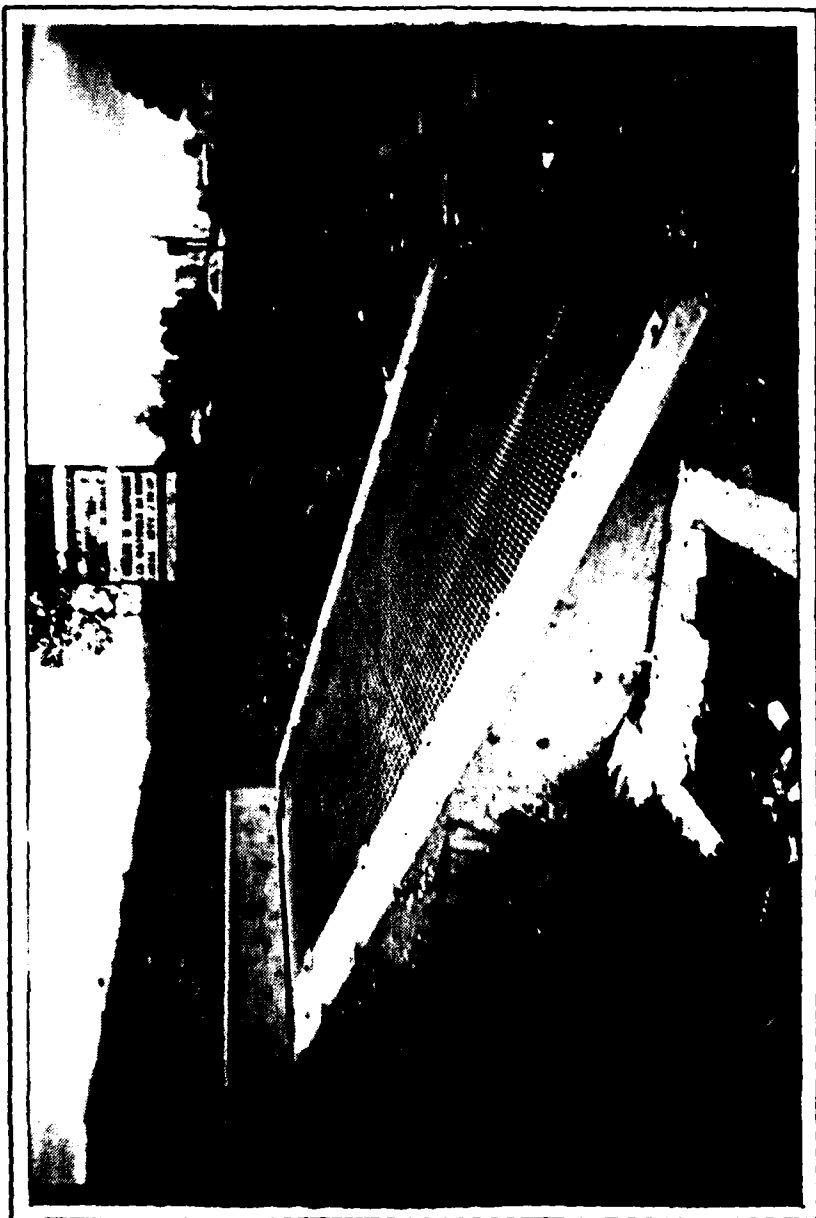
PHOTOGRAPH NO. 3

The exposed portions of the transition structure at the end of the conduit were inspected and found to be in generally good condition. The joints between the head wall and wing walls have opened and should be sealed.

TRANSITION SECTION BETWEEN DISCHARGE  
CONDUIT AND CULVERT UNDER U.S. ROUTE 1.

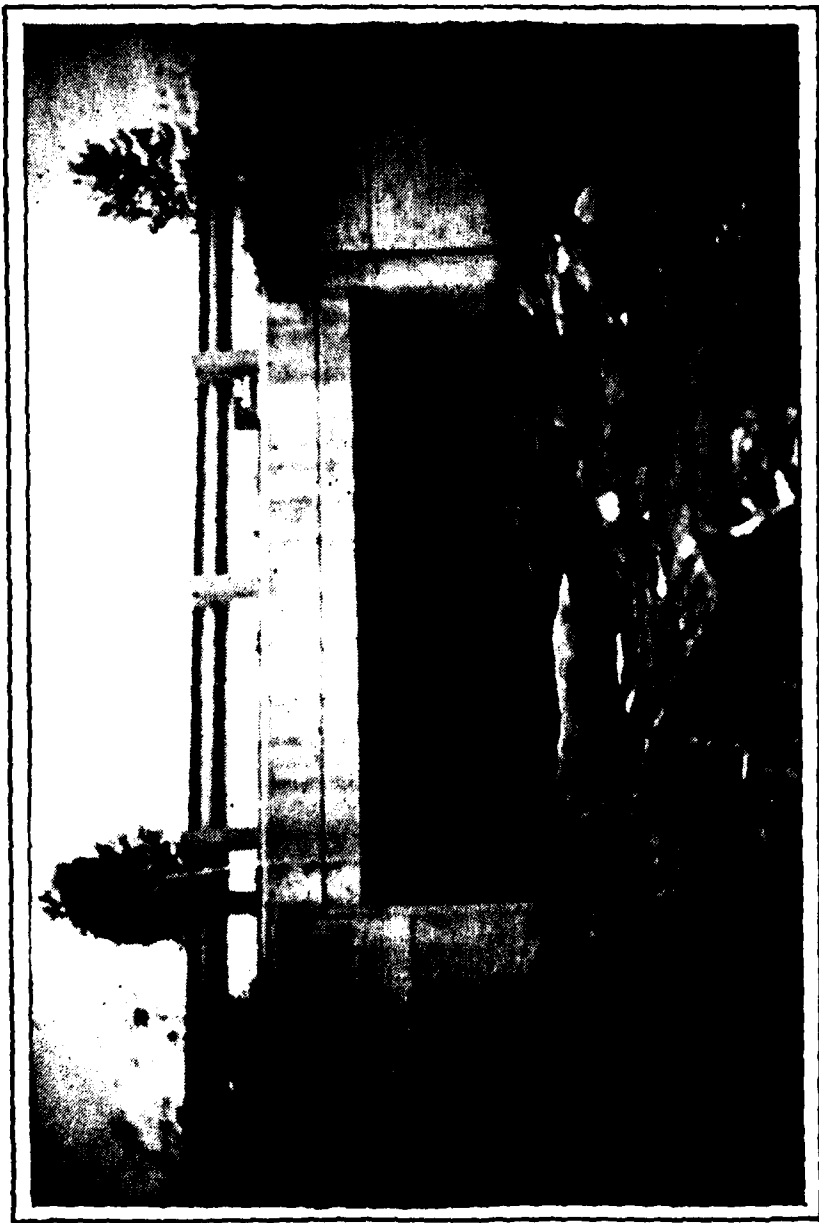
PHOTOGRAPH NO. 4

DOWNSTREAM SIDE OF CULVERT UNDER  
U.S. ROUTE 1.

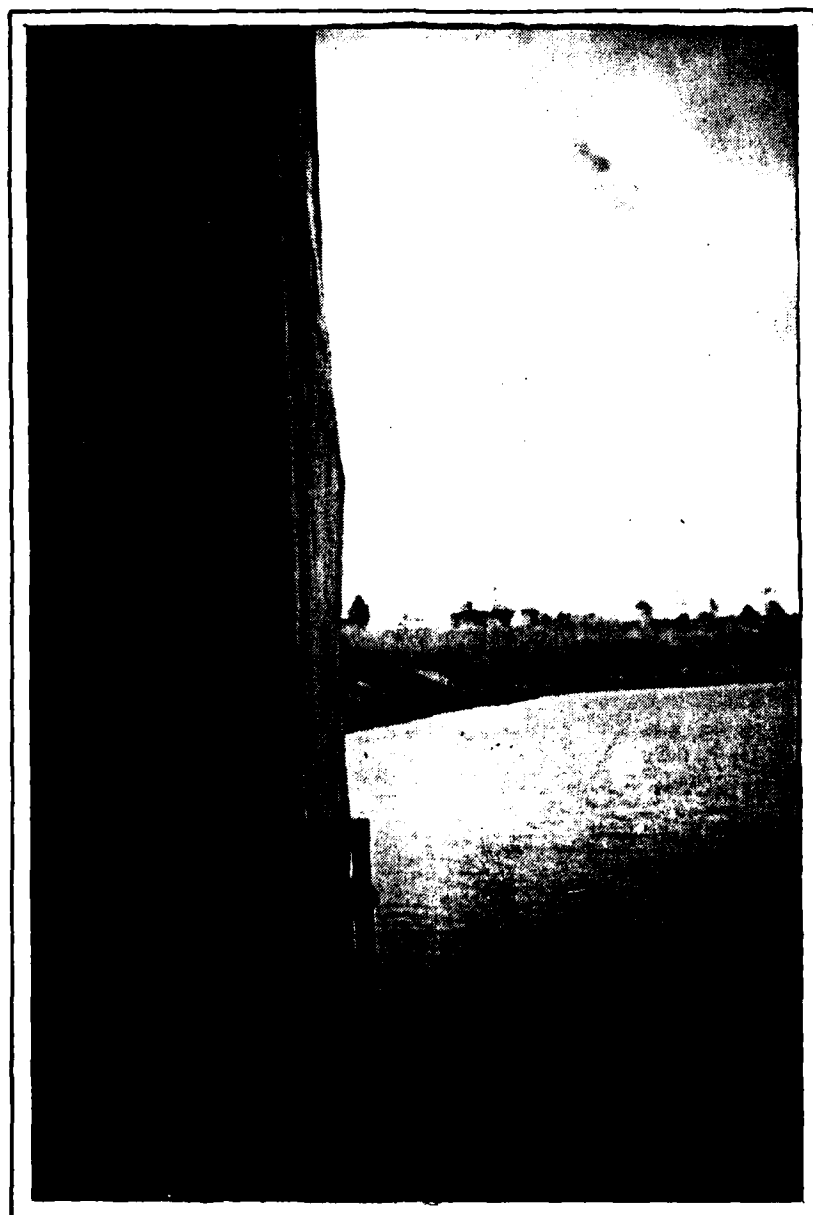
PHOTOGRAPH NO. 10

INTAKE TOWER FORMS APPARENTLY  
DEFLECTED DURING CONSTRUCTION.

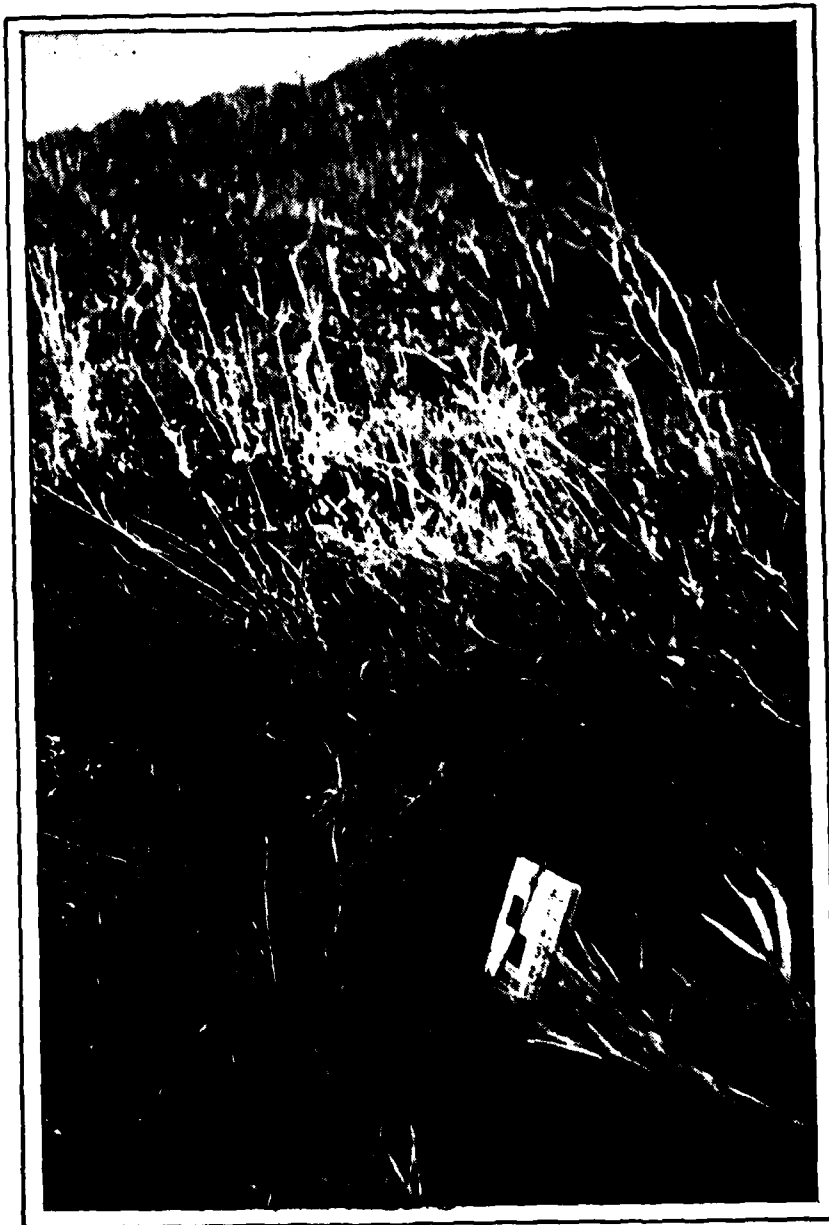
PHOTOGRAPH NO. 11

The upstream slope at the water line shows minor erosion/foot traffic damage.

DAMAGE TO SLOPE NEAR WATER  
LINE, PROBABLY CAUSED BY  
FOOT TRAFFIC.
